This home overlooking Sydney's beautiful Burraneer Bay had an existing swimming pool which was in very poor condition.

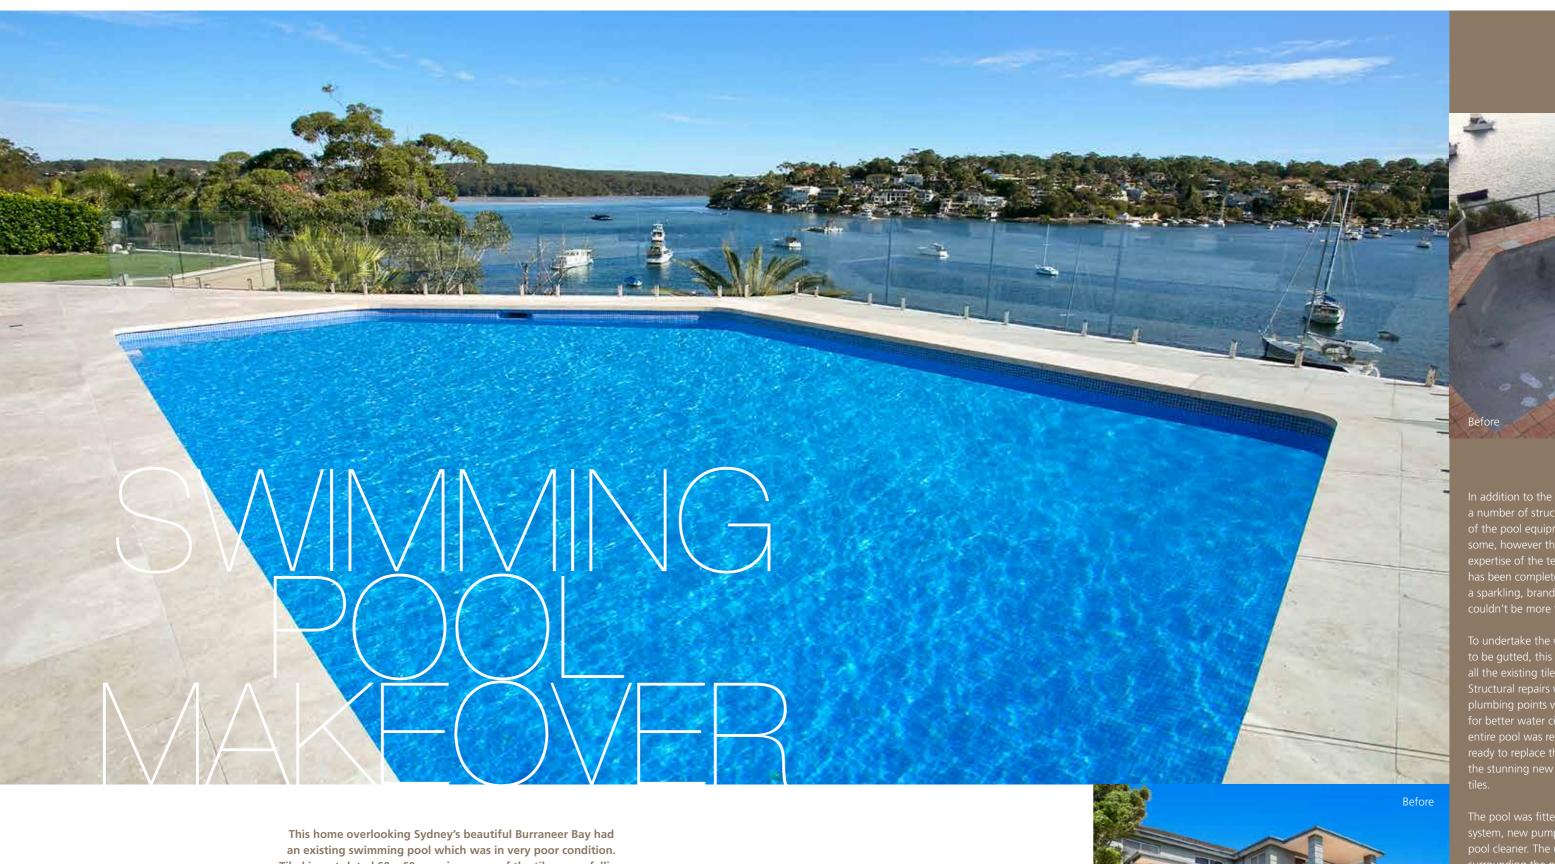
Tiled in out-dated 60 x 60 mosaics, many of the tiles were falling off the walls and floor due to poor workmanship, and like the inside of the pool, the dark, uninviting terracotta tiles on the pool surrounds also needed updating.

To undertake the work, the entire pool needed to be gutted, this included the removal of all the existing tiles and the cement render. Structural repairs were undertaken, and some plumbing points were also moved to allow for better water circulation and filtration. The entire pool was re-rendered and waterproofed, ready to replace the interior of the pool with the stunning new 20 x20mm Ezarri glass mosaic tiles

The pool was fitted with a new filtration system, new pump, chlorinator, and a robotic pool cleaner. The unappealing terracotta tiles surrounding the pool were also replaced with a stunning travertine tiles finished with a square edge for a crisp, clean and modern look.

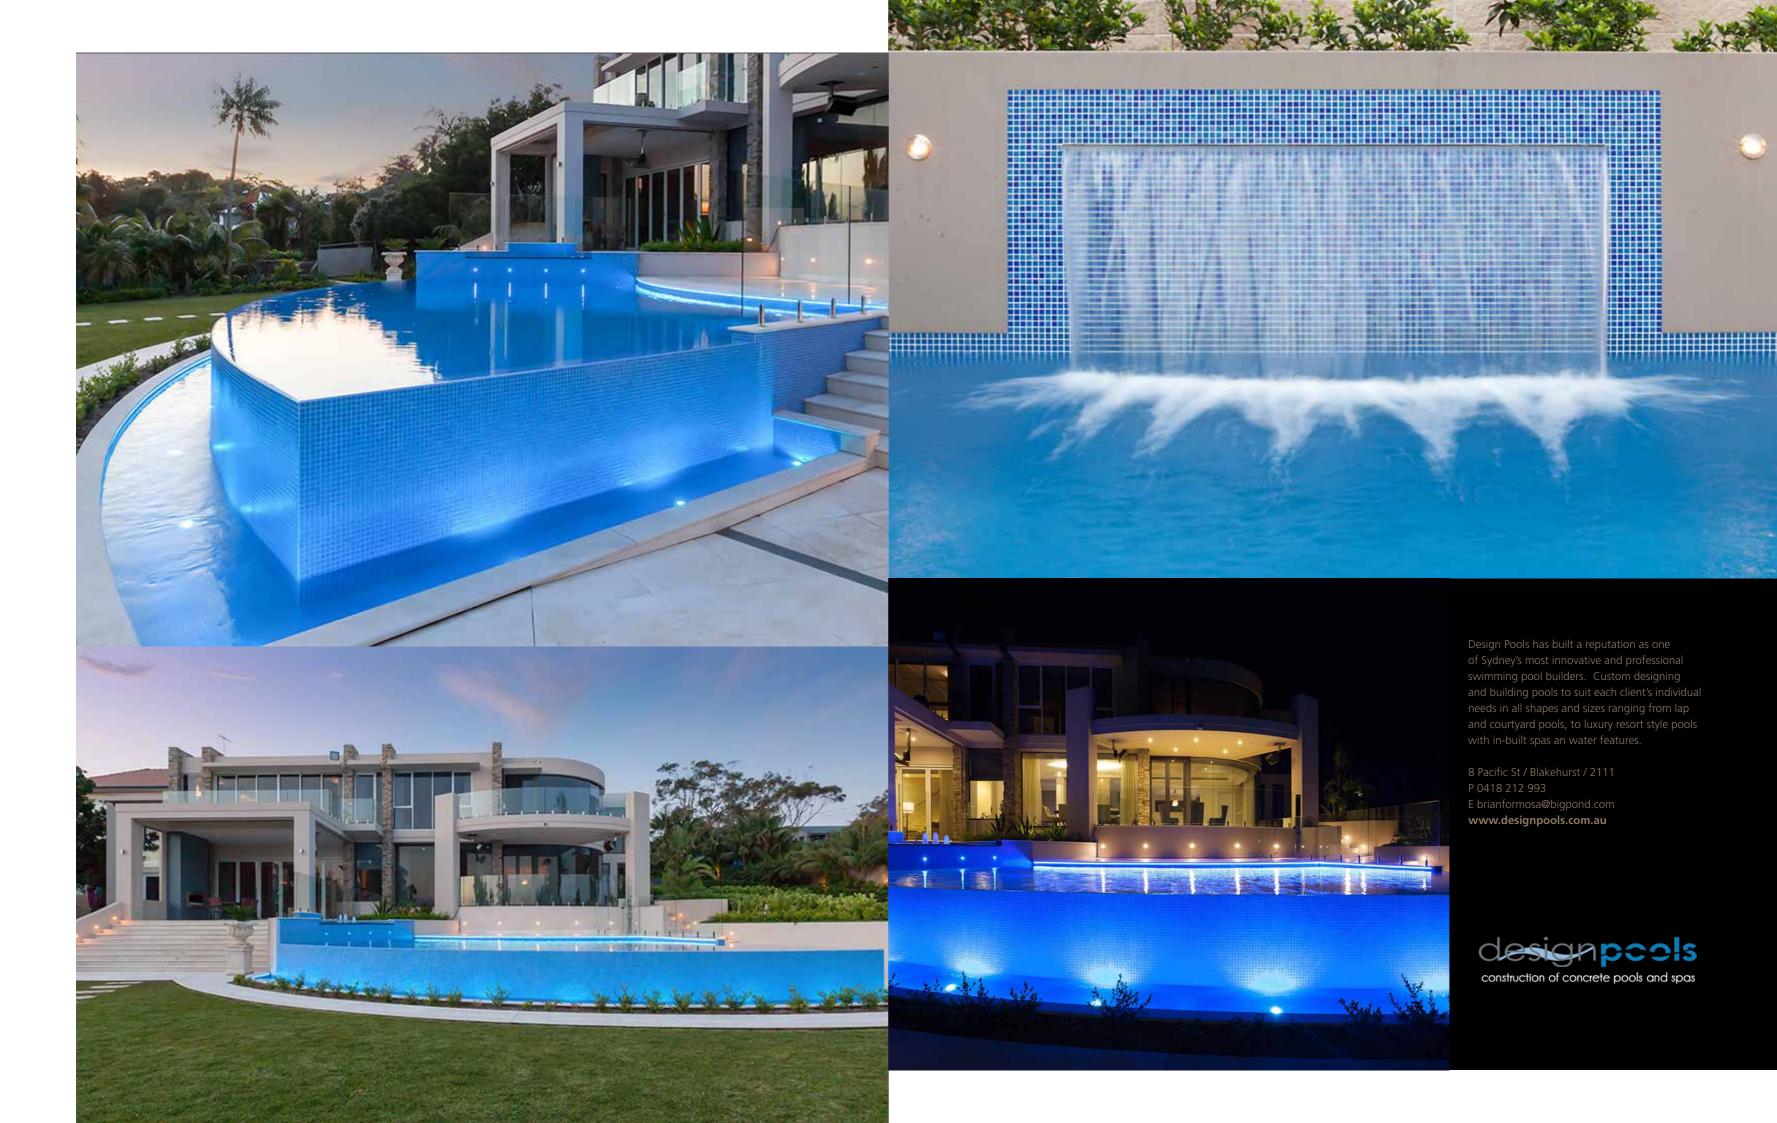
The outcome is a pool as sparkling and as beautiful as the bay on the right.
